Architectural Heritage Impact Assessment

Proposed Refurbishment Work to 22 and 23 Thomas Hill, Waterford city

Report on the proposed works for the purpose of a refurbishment housing scheme, in accordance with Part XI of the Planning & Development Act 2000, as amended, and Part 8, Article 81 of the Planning and Development Regulations 2001.

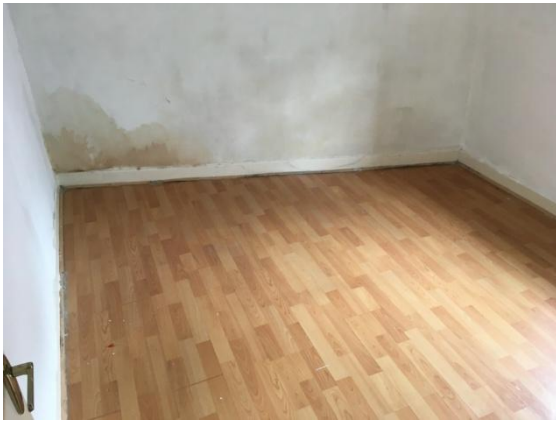
Fig.1; Damp to end gable-wall at second-floor level.

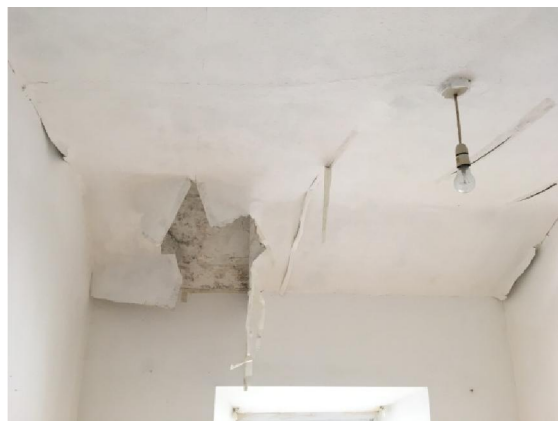
Fig.4; Ceiling at the top of stairs, showing damp ingress.

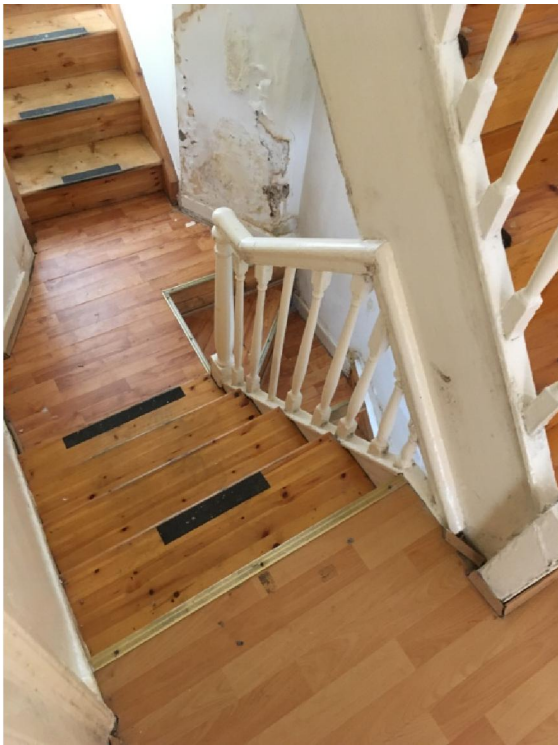
Fig.9; View from first-floor; note damp on party-wall.

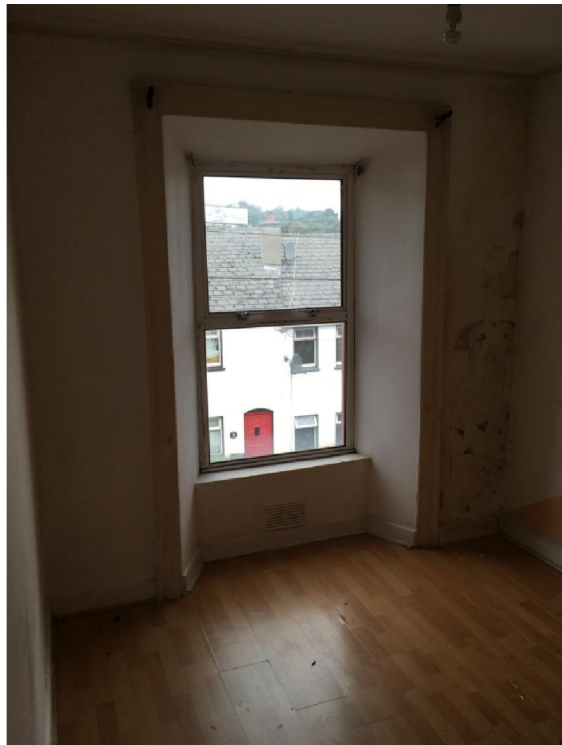
Fig.10; Window to Thomas Hill at first-floor; no shutters.

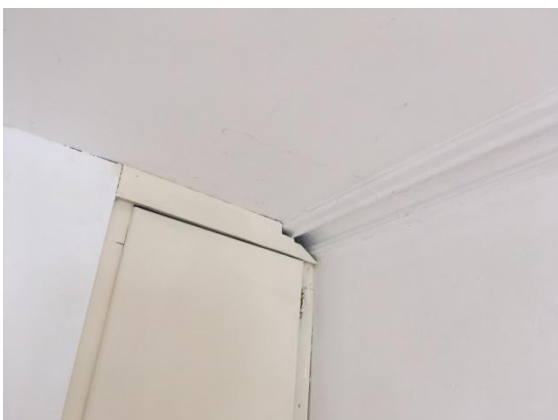
Fig.11; Internal finish at first-floor; arrangement of cupboards against the coving detail suggests sub-division of larger room.

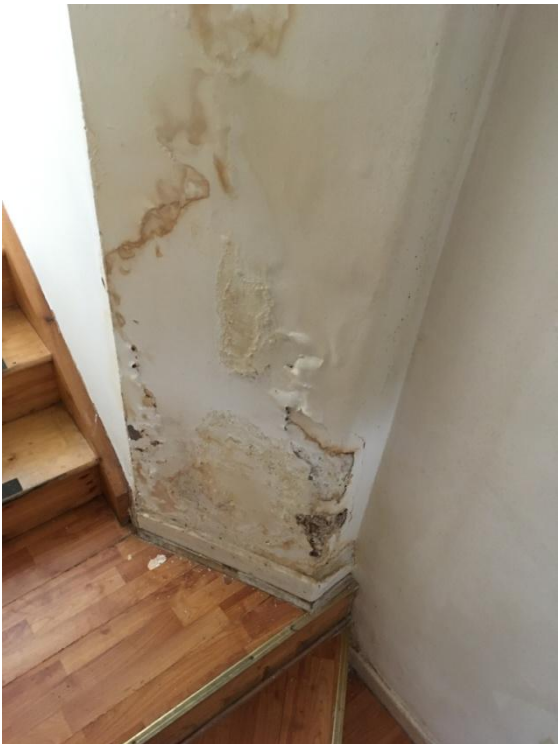
Fig.15; Severe damp at mezzanine-level.

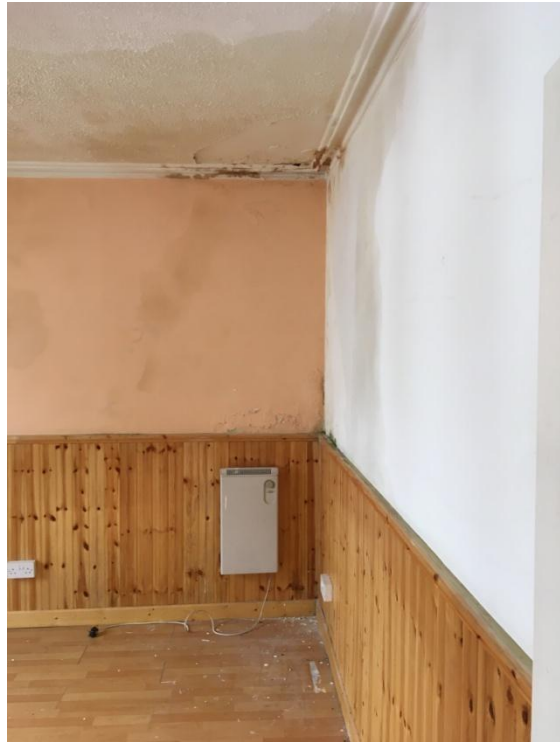
Fig.24; Ground-floor, front room; extreme damp ingress.

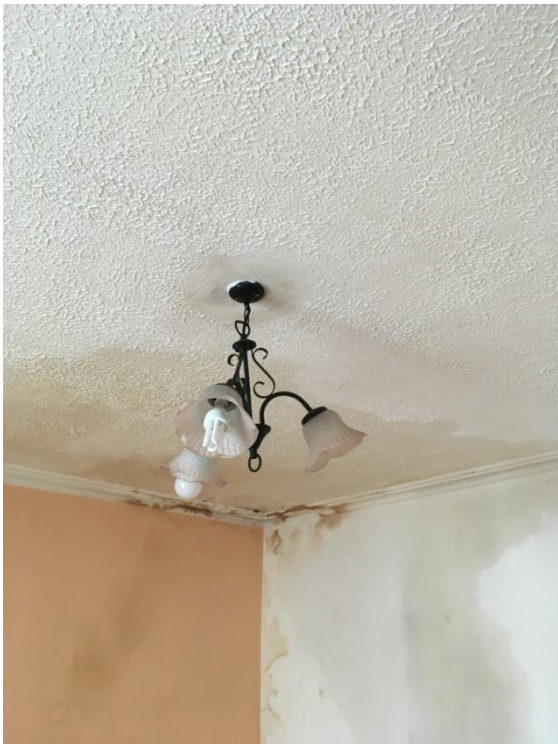
Fig.25; Ground front-room; extreme damp ingress.

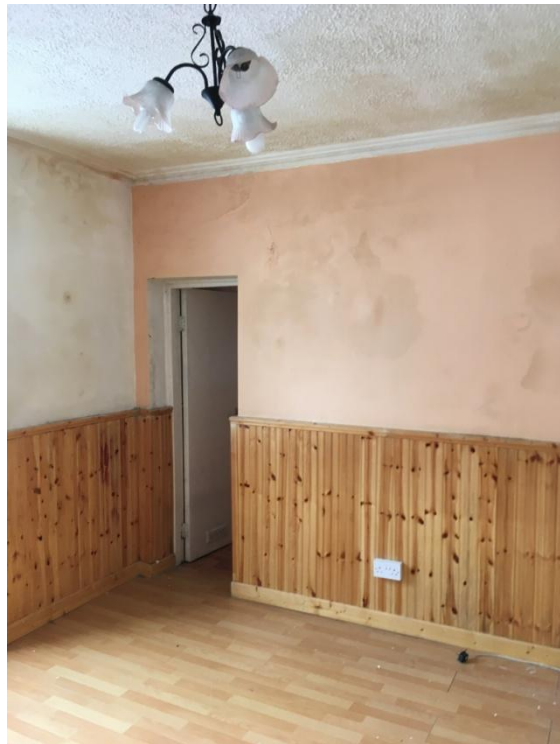
Fig.26; Extreme damp, and door to side-room which stands adjacent to the higher-level Queens Terrace

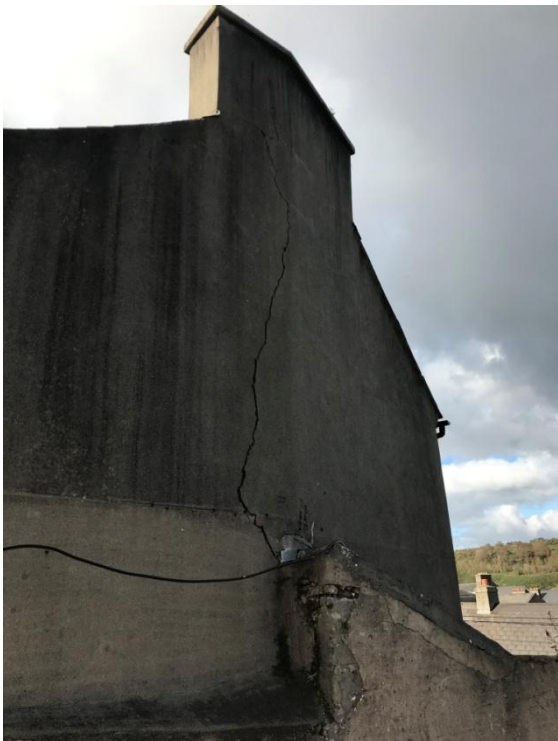
Fig.35; Significant crack in end gable to Queens Trc.

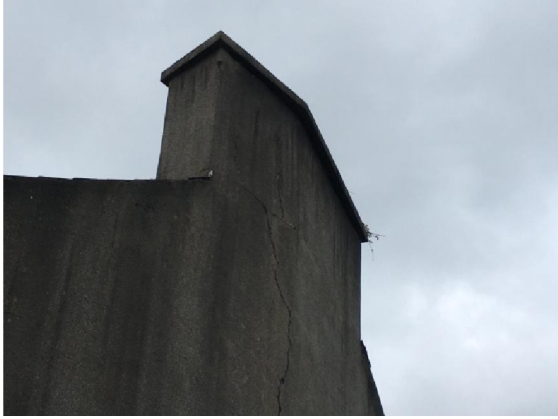
Fig.37; Significant crack in end gable to Queens Trc.

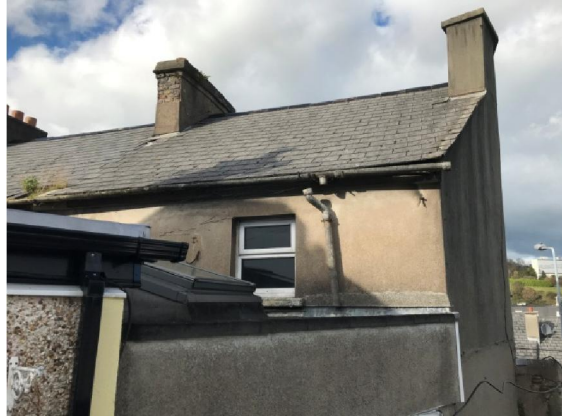
Fig.38; Defective gutters, asbestos tiles, missing render.

1. Removal of asbestos roof tiles and replacement with appropriate slates, to both houses,
2. Re-plastering of chimney stacks generally
3. Re-plastering of end gable-wall facing on to Queens Terrace,
4. Replacement of rainwater goods with matching equivalent type generally
5. Repair of existing timber sliding-sash windows to no.22

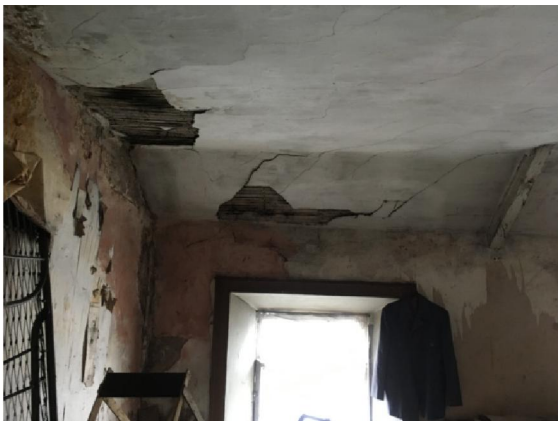
Fig.45; Top-floor, damp ingress through ceiling and walls.

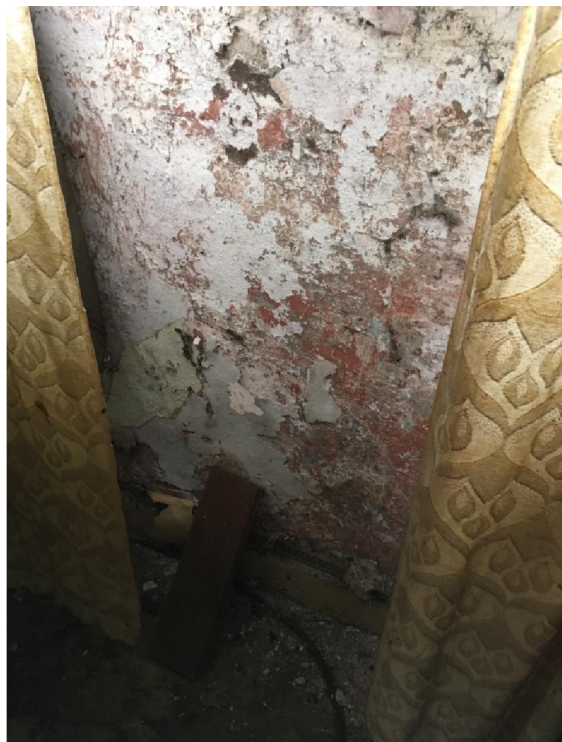
Fig.48; Damp ingress on front wall between windows.

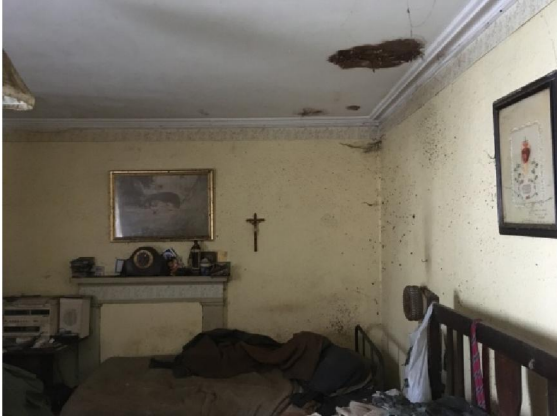
Fig.55; First-floor; original features, damp and stains

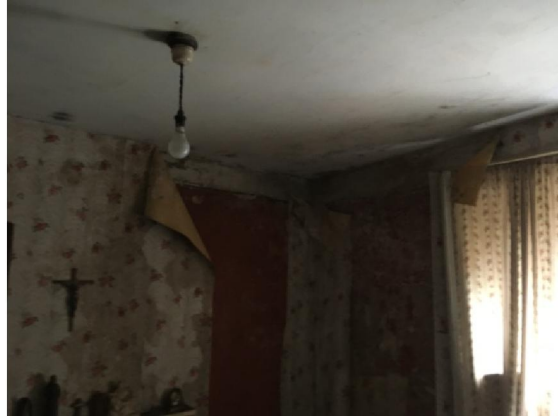
Fig.56; Damp walls causing wallpaper to peel off.

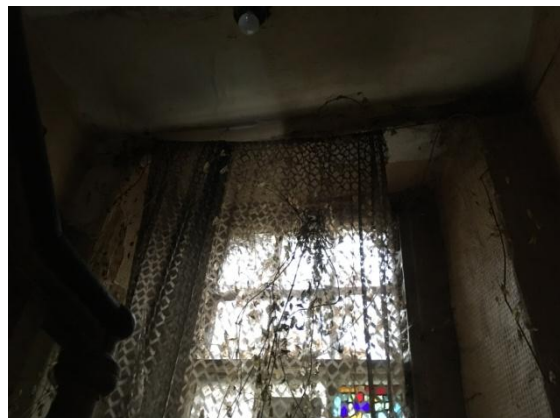
Fig.60; Front window to Thomas Hill; original sliding sash
