PLANNING & CONSERVATION IMPACT REPORT

FOR DEVELOPMENT AT THE PREMISES FORMERLY KNOWN AS FENNEL'S PUB AND UNIACKE'S SHOP, MAIN STREET, CAPPOQUIN, CO.WATERFORD.

WATERFORD CO. COUNCIL – Development at the premises formerly known as Fennell's Pub & Uniacke's Shop, Main Street, Cappoquin, Co. Waterford

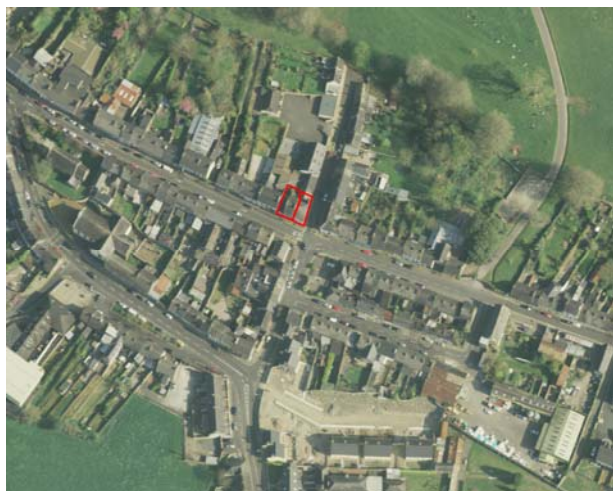
Contemporary Aerial view showing Fennell's and Uniackes today on Main street. Further development is shown to neighbouring properties to the rear. Back annex buildings to Uniackes have been removed or have collapsed.

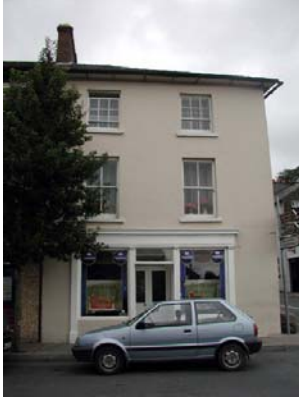
Recent Historic photograph of Fennell's, sourced from NIAH record. Front and side view of the front of Fennell's Pub. This image shows Fennell's Pub in operation. Original features are visible including sash windows – which are not there today.

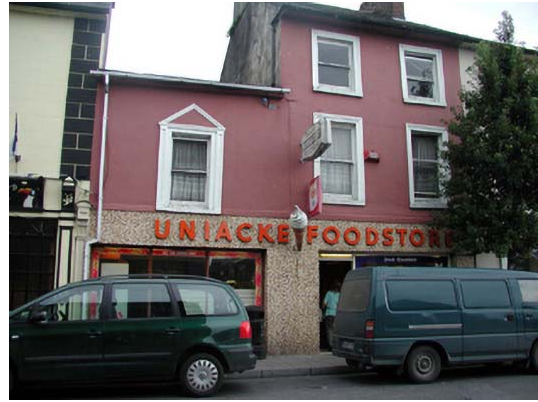
Recent Historic photograph of Fennell's, sourced from NIAH record. Front view of Uniacke's shop showing the shop in operation. Shop signage visible on Mosaic shopfront and at upper levels of front elevation
