# PLANNING & CONSERVATION IMPACT REPORT

FOR DEVELOPMENT AT THE PREMISES FORMERLY KNOWN AS MOORE'S HOTEL, MAIN STREET,  
CAPPOQUINN, CO.WATERFORD

### WATERFORD CO. COUNCIL – Development at the premises formerly known as Moore's Hotel, Main Street, Cappoquin, Co Waterford.

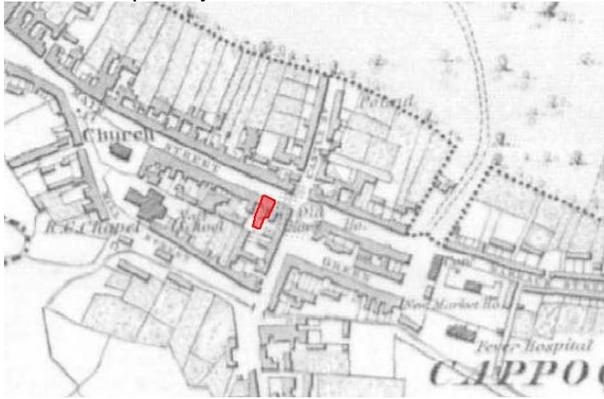
Ordnance Survey, surveyed 1837-1842. A building is located on the Moore's site on Main Street. Note the terrace continues to the corner of Cook street.

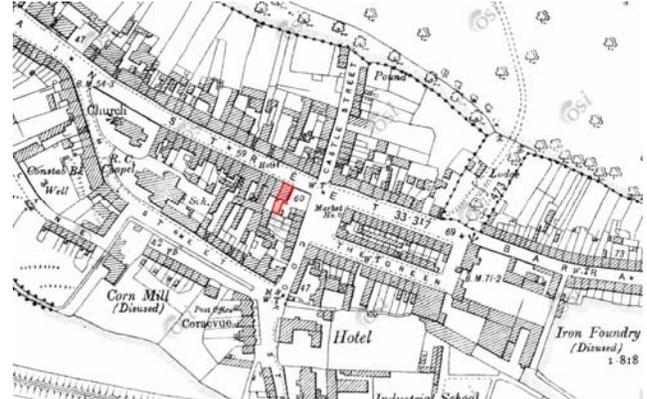
Ordnance Survey, surveyed 1888-1912. The building that became Moore's hotel is shown here as two adjacent units, rather than one. Note there is no building on corner to cook street.

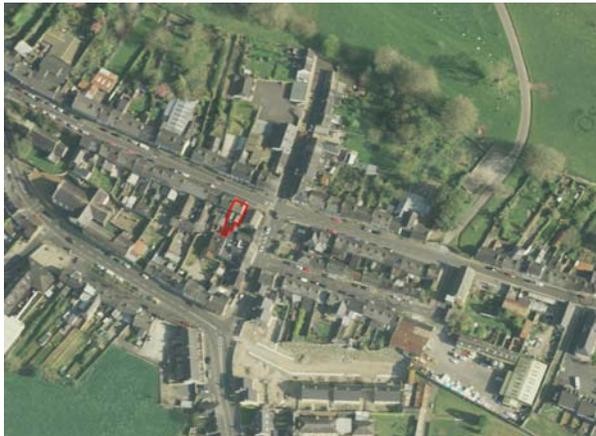
Contemporary Aerial view showing Moore's and Main street development. Further development to neighbouring properties has decreased the size of Moore's site to rear. Single storey former bank building built circa 1930 located on adjacent corner site.

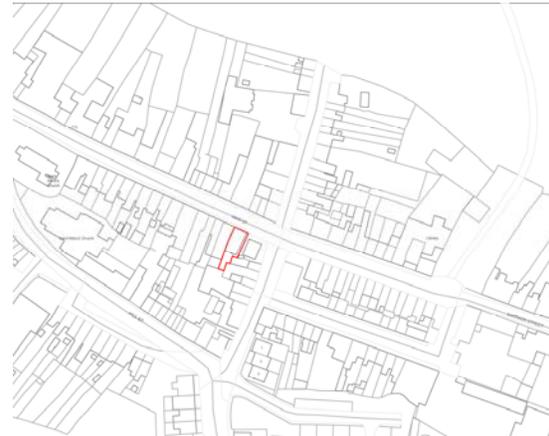
Contemporary Ordnance Survey Map of Moore's showing increased development surrounding the site and side passage to rear.

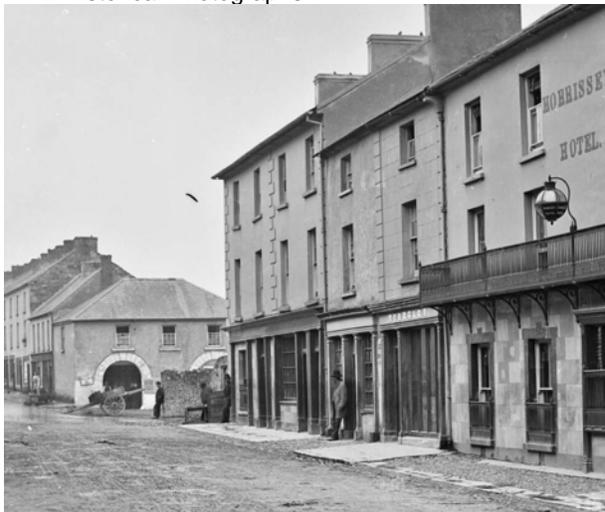
Historic photograph published/created ca. 1865-1914. Front view of the front of Moore's (centre) taken from west. Moore's hotel showing it's original front façade, with a simple painted timber shop front and plaster quoins to corners and at centre. This image suggests that these buildings may originally have been two separate units.

As shown in the photographic study above, the plaster mould detailing that exists to Moore's hotel façade today is not original but is still historically significant and dates back to the start of the 20<sup>th</sup> century. Whilst not original, the plasterwork features are characteristic to the town of Cappoquin. Similar detailing is found on other protected structures on Main Street including Blackwater House and the former Walsh's Hotel.

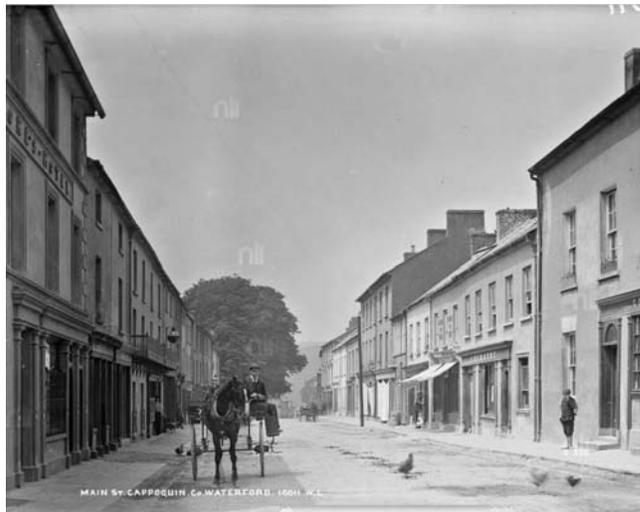
Historic photograph published/created ca. 1880-1900. Front view of the front of Moore's (near left) taken from east. Front façade has been upgraded with the decorative plasterwork that is shown today. Moore's Hotel is joined as one building.

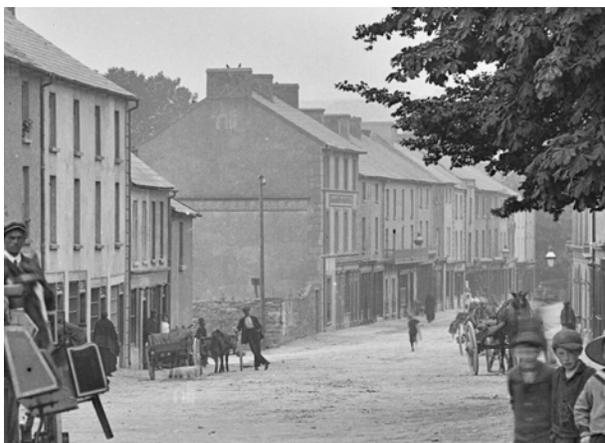
Historic photograph published/created ca. 1865-1914. Front view of the front of Moore's (centre) taken from east. Side elevation showing painted lettering within moulded surround. Adjacent corner site is empty but is walled off to Cook Street and the square. Side passage gate is shown in same location as new gate today.

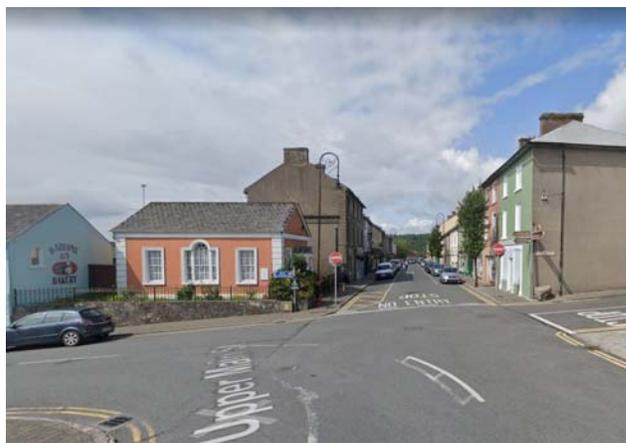
Contemporary view showing side and front elevation. Adjacent corner site with former bank building built ca. 1930.
